UNITED STATES ENVIRONMENTAL PROTECTION AGENCY
REGION IX – SOUTHERN CALIFORNIA FIELD OFFICE
600 WILSHIRE BLVD, Suite 1460
Los Angeles, CA 90017

**Region 9 Enforcement Division
75 Hawthorne Street
San Francisco, CA 94105
INSPECTION REPORT**

Inspection Date(s):	06/09/16		
Time:	Entry: 1:50 pm	Exit: 4:00 pm	
Media:	Water		
Regulatory Program(s)	CWA NPDES/Industrial Stormwater		
Company Name:	Allen Asset Management Group LLC		
Facility or Site Name:	Plastic Recycling Plant		
Facility/Site Physical Location:	14131 South Avalon Blvd.		
(city, state, zip code)	Los Angeles, CA 90061		
Geographic Coordinates:	33°54'11.00"N / 118°15'56.00"W		
Weather	Sunny, no clouds		
County:	Los Angeles		
Facility/Site Contact:	Mr. John Fang	Site Manager	
	Office #:	[REDACTED]	
Facility/Site QISP:	NA		
Facility/Site Identifier:	NA (UNPERMITTED)		
Media Number:	NA		
NAICS:	326199 – All Other Plastics Product Manufacturing (determined by Haskell based on observations during inspection of the Facility)		
SIC:	3089 – Plastics Products, Not Elsewhere Classified (determined by Haskell based on observations during inspection of Facility)		
Facility/Site Personnel Participating in Inspection:

Allen Asset Managem

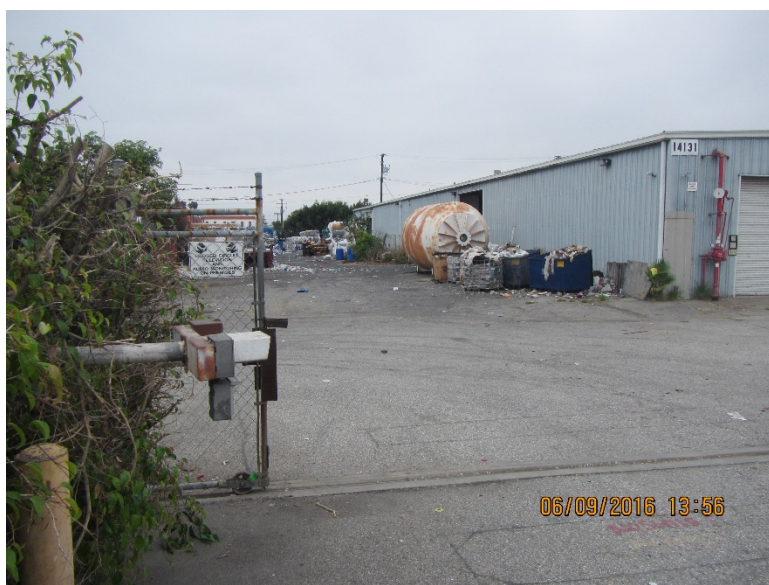
IMG_0098.JPG. Entrance of Allen Plastic Recycling Plant off South Avalon Blvd.

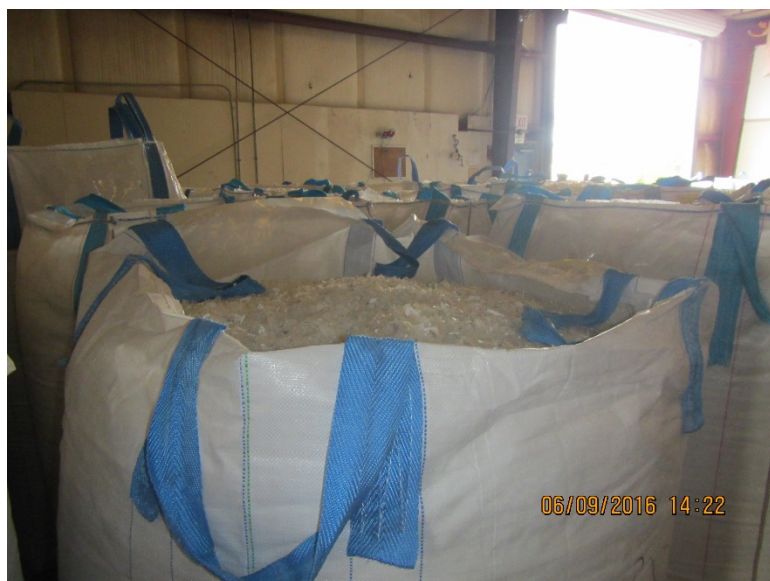
IMG_0104.JPG. Super sacks of finished product; plastic fragments.

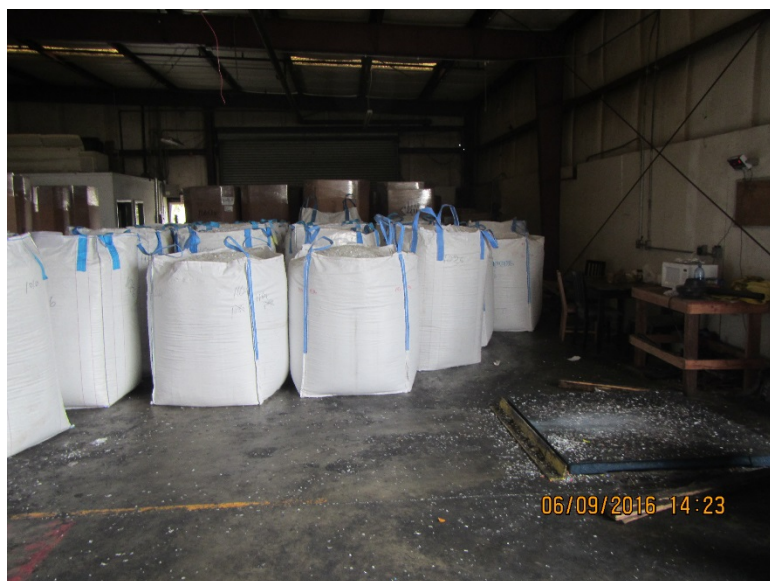
IMG_0105.JPG. Additional photo of super sacks of finished product; plastic fragments.

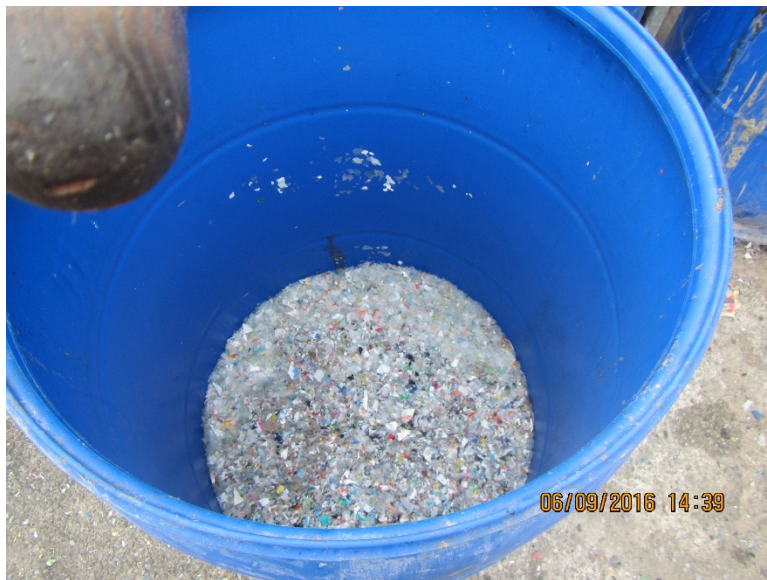
IMG_0129.JPG. Interior view of one open container from Image 0128, filled with plastic fragments.

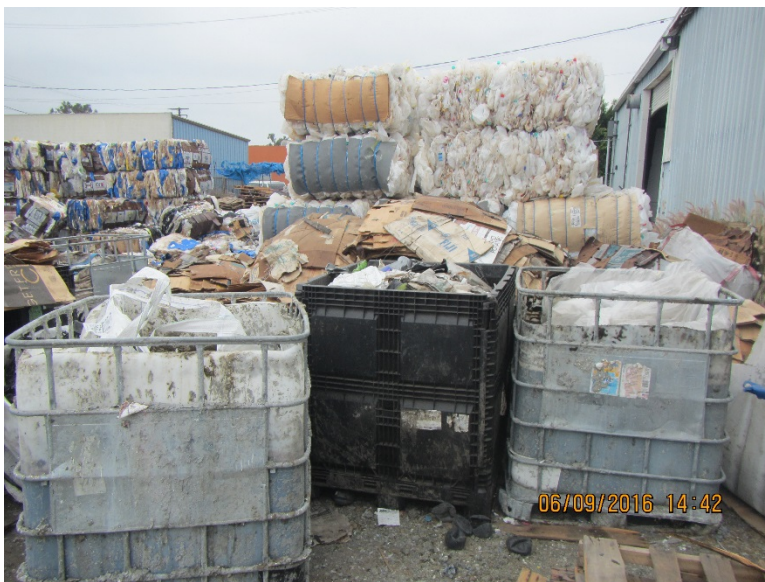
5. I observed the mismanagement of material storage to prevent discharge of pollutants in stormwater. For example, numerous bales of plastic material and folded super sacks were stacked outside throughout the facility. I also observed numerous amounts of plastic containers that were scattered throughout the facility on impervious pavement.

IMG_0137.JPG. Stacks of baled plastic materials behind open containers of plastic materials all outside on northern parking lot.

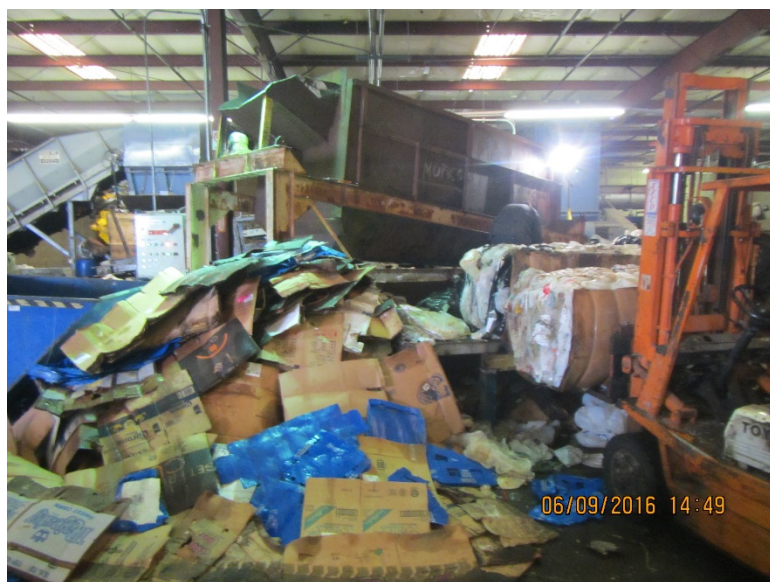
IMG_0149.JPG. Plastic materials being loaded into plastic shredder.

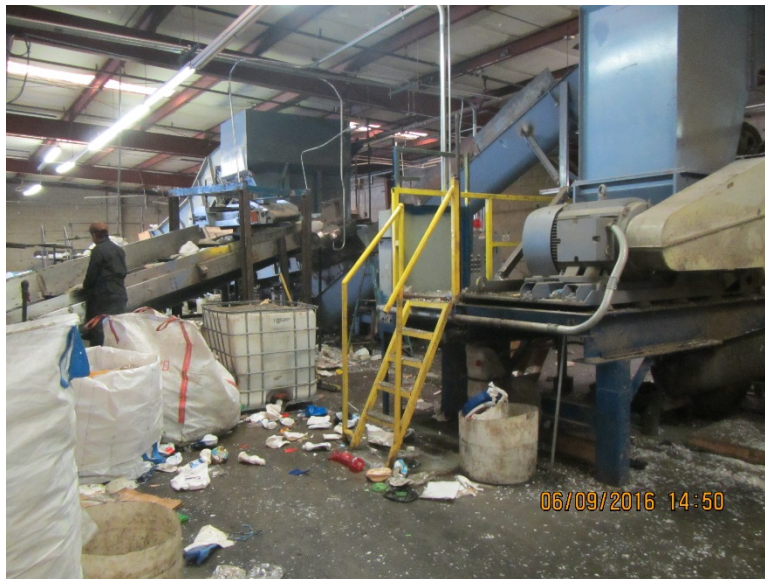
IMG_0151.JPG. plastic materials be sorted before shredding.

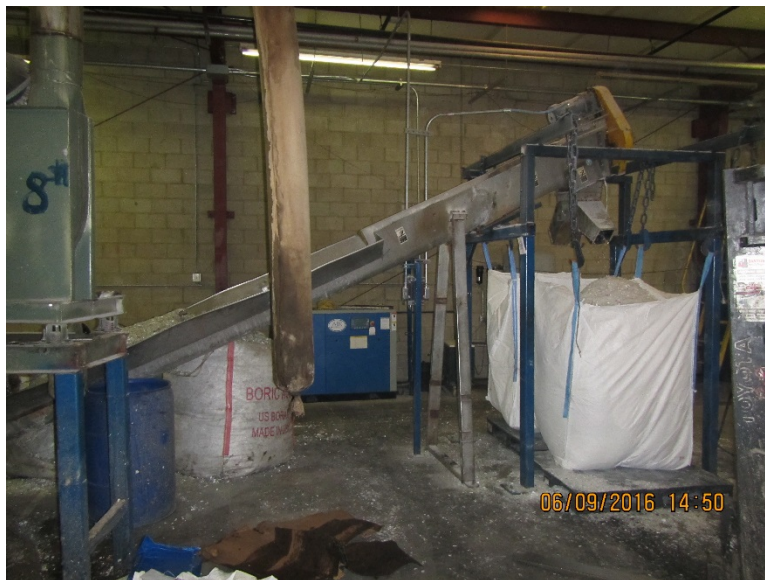
IMG_0152.JPG. Super sacks being filled with plastic fragments.

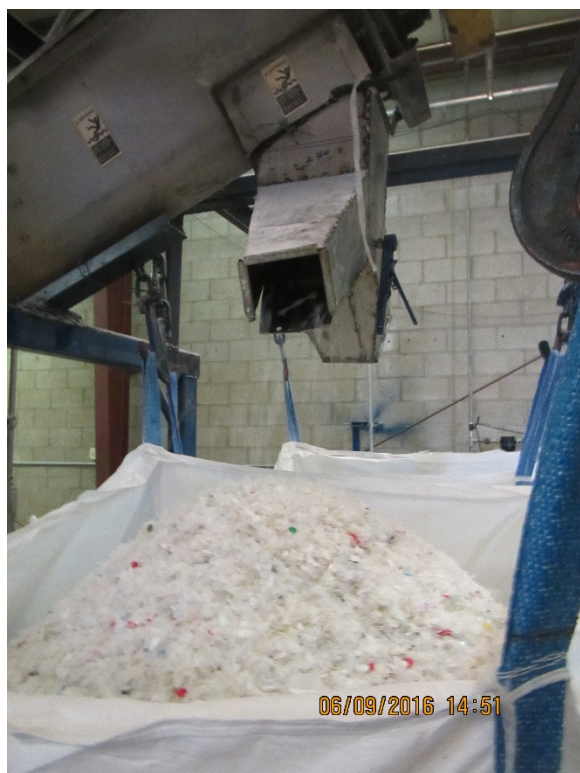
IMG_0154.JPG. Zoomed in super sack being filled with plastic fragments from Image 0152.

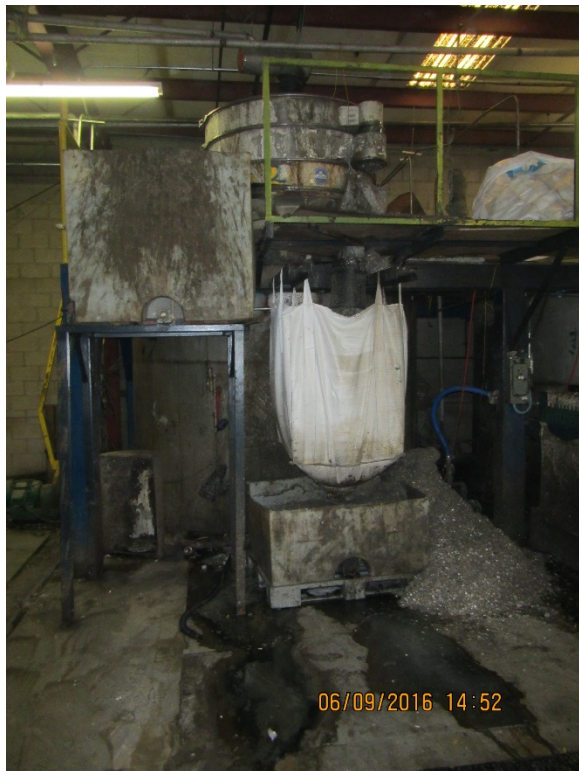
IMG_0155.JPG. Plastic fragment collector before washing.

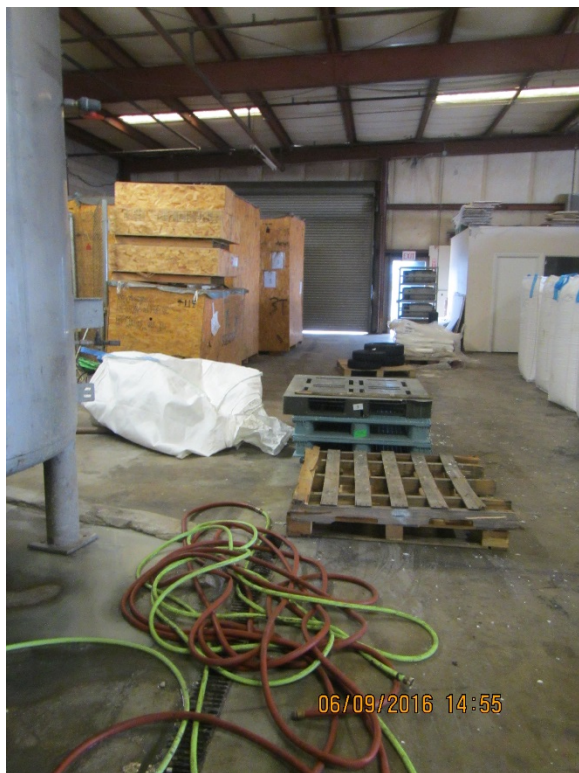
IMG_0159.JPG. Eastward view of water collection trench from Image 0158. Note shipping crates with the abbreviation "3T" spray painted on.

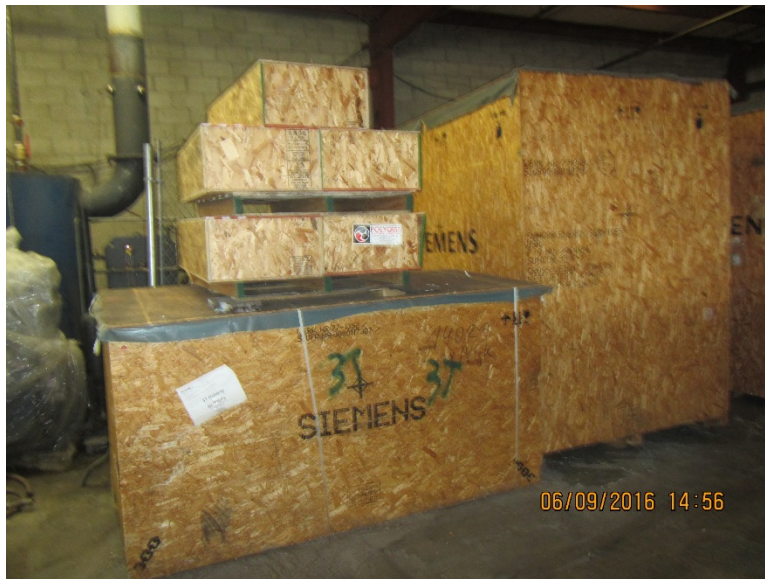
IMG_0160.JPG. Northward view of shipping crates with the abbreviation "3T" from image 0159.

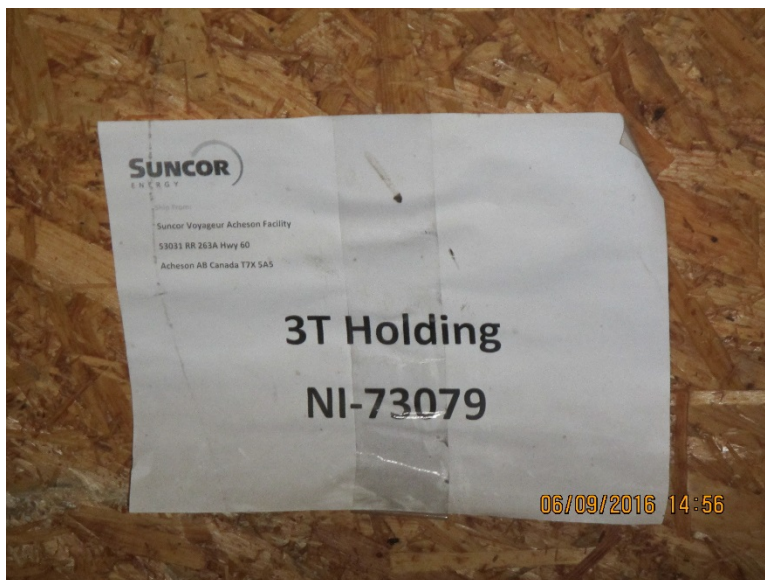
IMG_0161.JPG. Zoomed in "3T Holding" label on shipping crates from Image 0160.

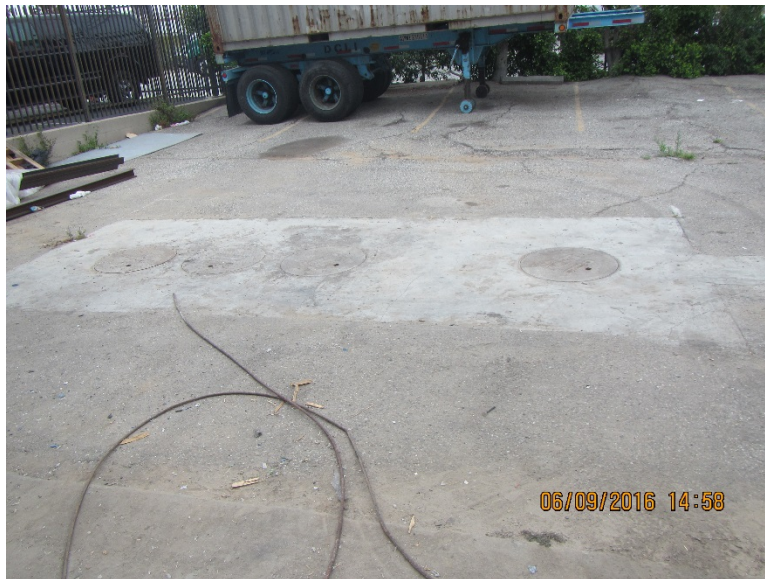
IMG_0164.JPG. Eastward view of four manholes, which may collect process water from indoor trench as shown in Images 0158 and 0159.

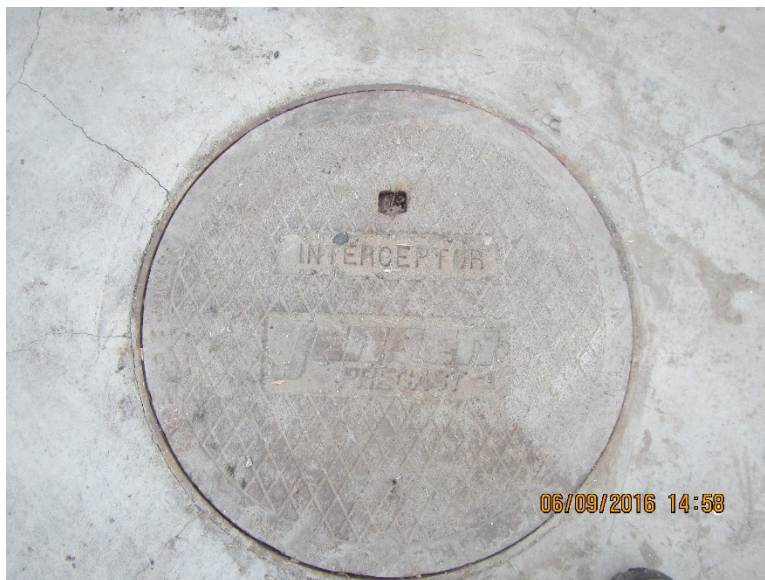
IMG_0165.JPG. Zoomed in image of the south most manhole shown in Image 0164.

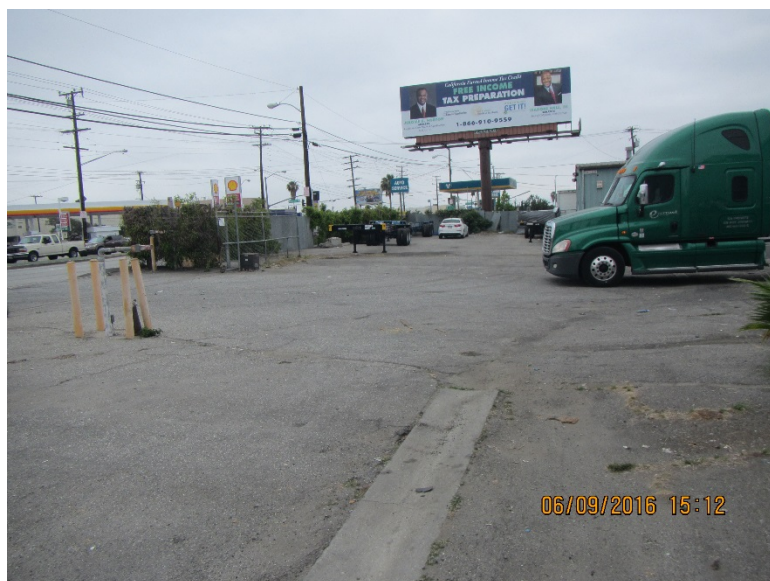
IMG_0166.JPG. Southward gradient of stormwater trench beginning from manholes in Image 0164.

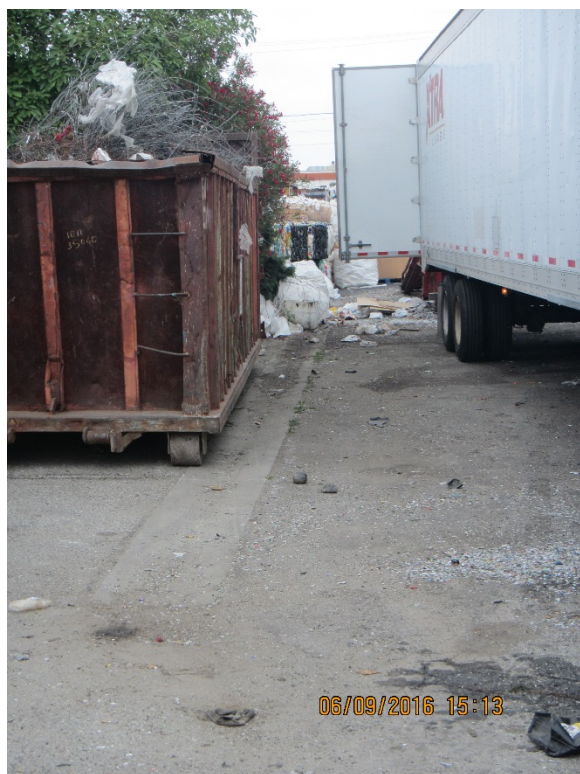
IMG_0167.JPG. Westward gradient of stormwater trench in parking lot.

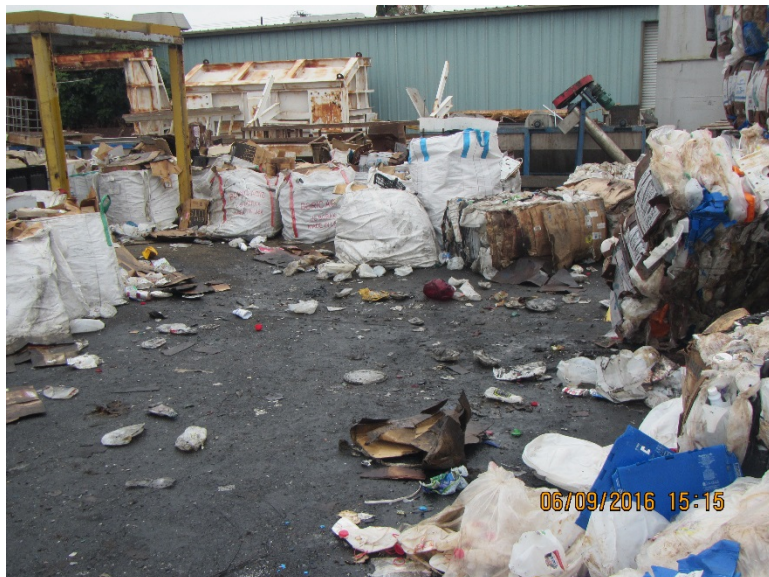
IMG_0168.JPG. Westward gradient of stormwater tench in parking lot continued.

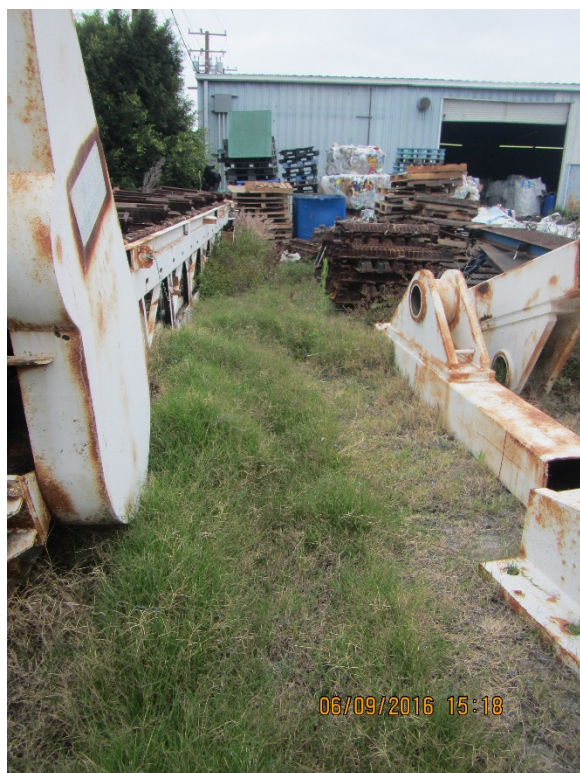
IMG_0170.JPG. Northward view of southward flow path commencing from trench adjacent to blue storage container from Image 0145. Note evidence of weed growth long flow path.

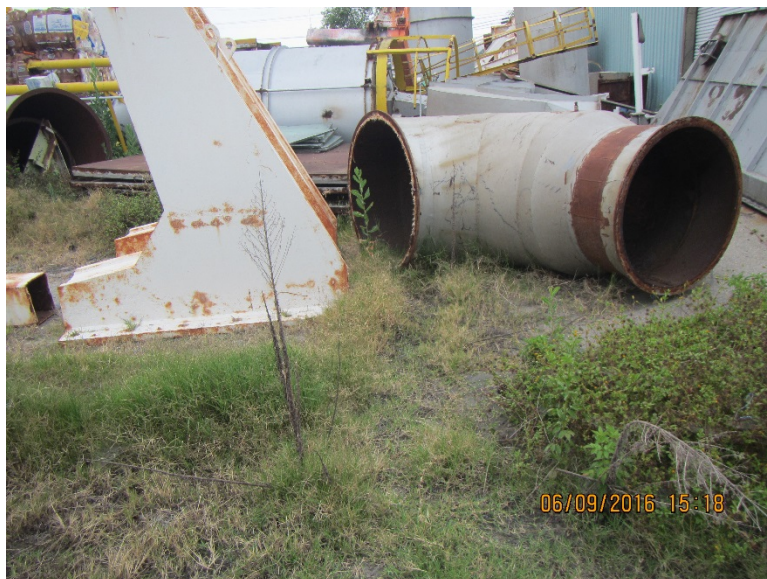
IMG_0171.JPG. Continuation of southward flow path (eastward view) from Image 0170. Note evidence of weed growth long flow path.

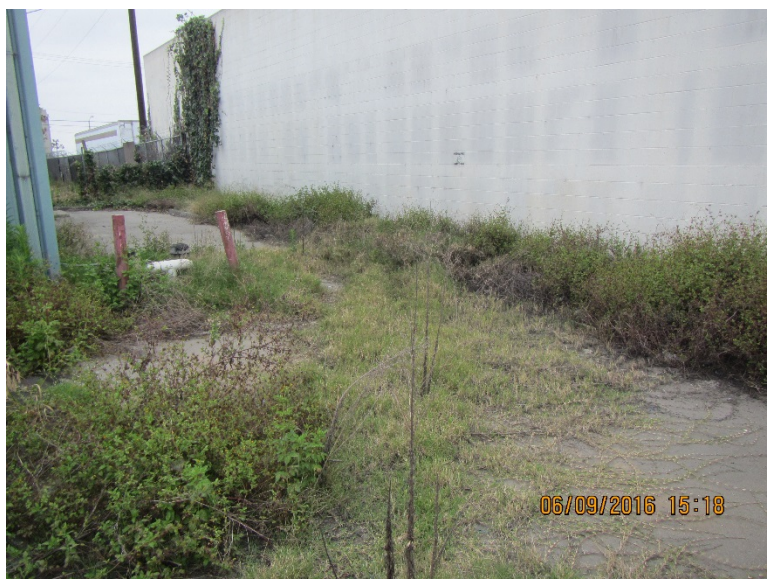
IMG_0173.JPG. Continuation of southwestern flow path merging with southward flow path from Image 0171. Note evidence of lighter southwestern weed growth merging with thicker weed growth along southward flow path (southward view)..

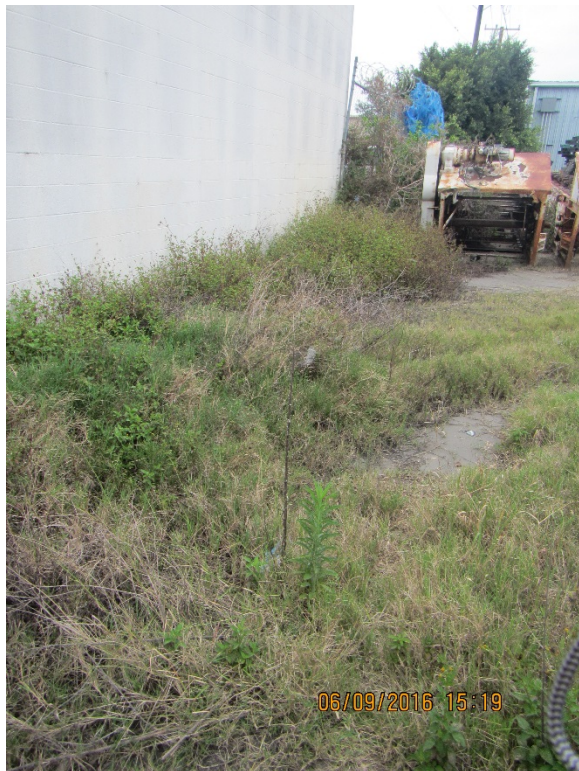
IMG_0174.JPG. Continuation of southward flow path with weeds from Image 0173. Note evidence of lighter southwestward weed growth merging with thicker weed growth along southward flow path (northward view). Flow path along facility boundary may be due to run-on as shown in image 0189.

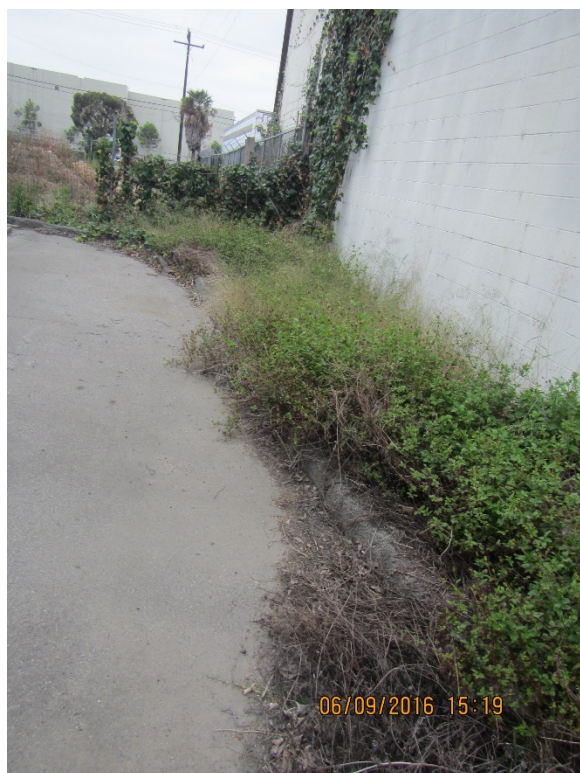
IMG_0175.JPG. Continuation of southward flow path with thick weeds from Image 0173 (southward view).

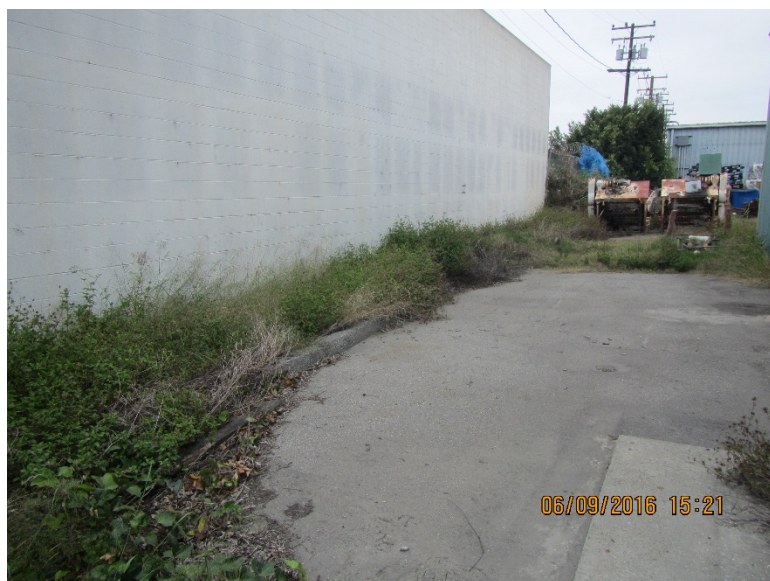
IMG_0176.JPG. Northward view of Image 0173.

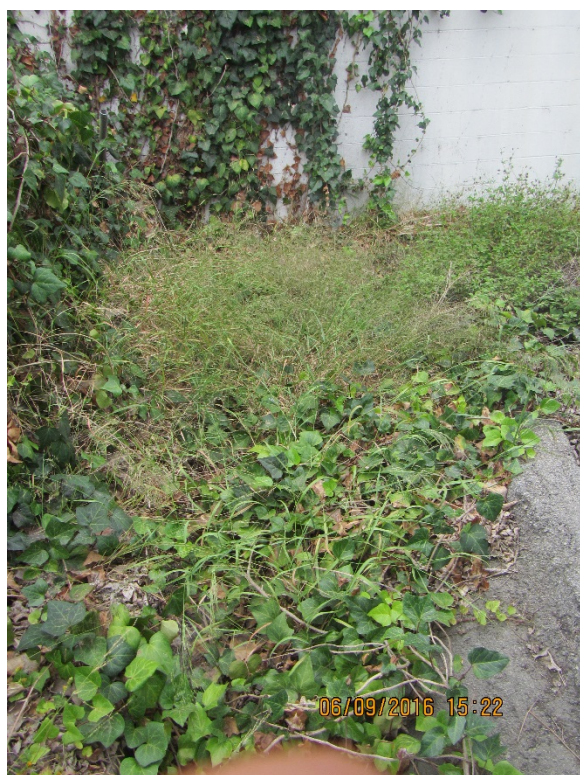
IMG_0177.JPG. Continuation of southward flow path with thick weeds from Image 0173 (southward view).

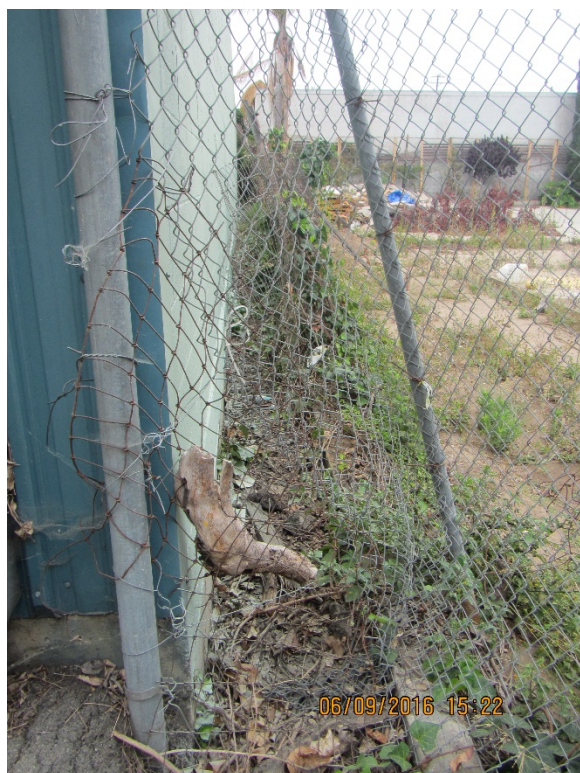
IMG_0179.JPG. Alternative flow path A from Image 0177. Flow path direction eastward behind an additional building along vacant lot boundary (eastward view).

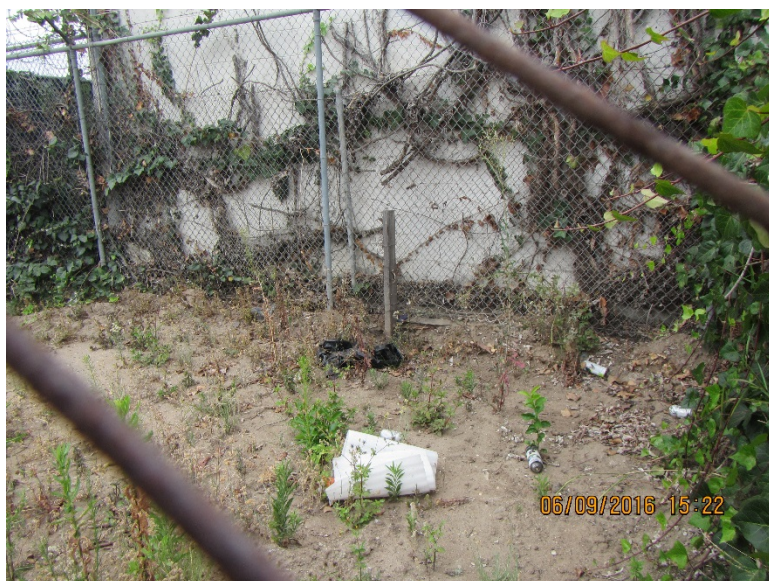
IMG_0181.JPG. Alternative flow path B from 0177. Flow path direction continues southward along boundary of neighbor building (southwestward view).

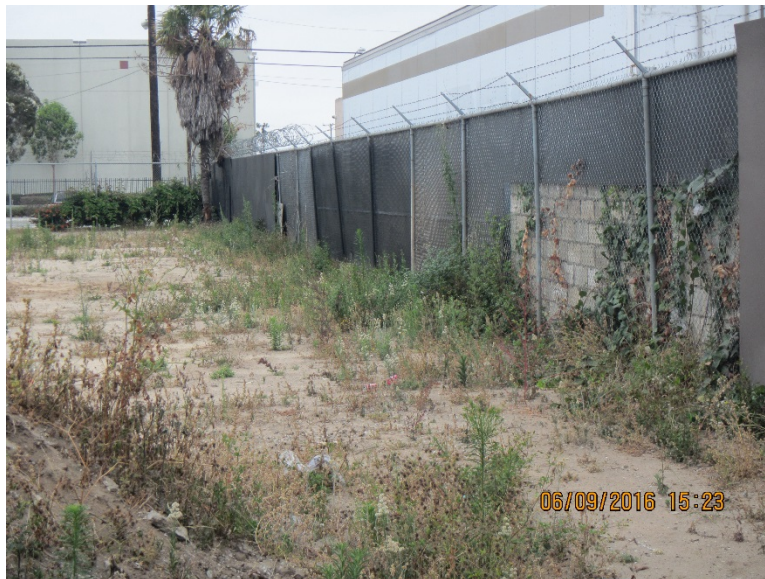
IMG_0183.JPG. Continuation of alternative flow path B from 0182. Note accumulated sediment along vacant boundary and weed growth. Note, weed growth may terminates at palm tree.

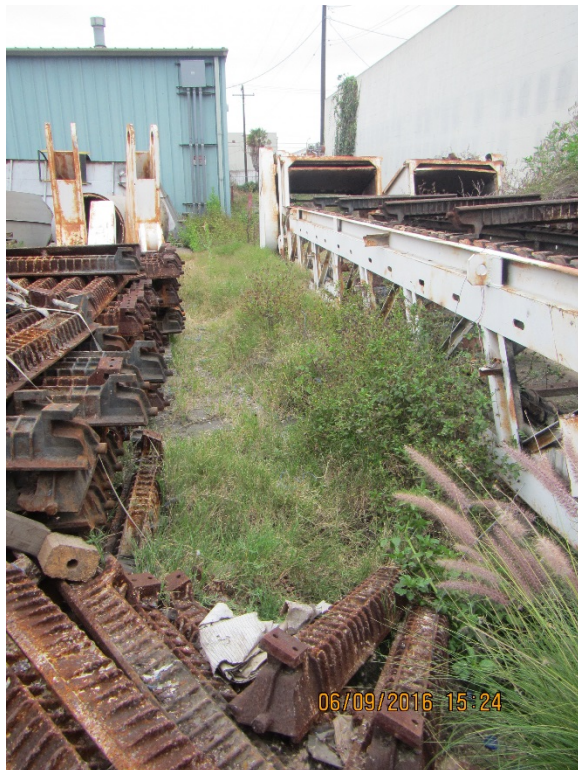
IMG_0185.JPG. Southward view of Image 0170 flow path.

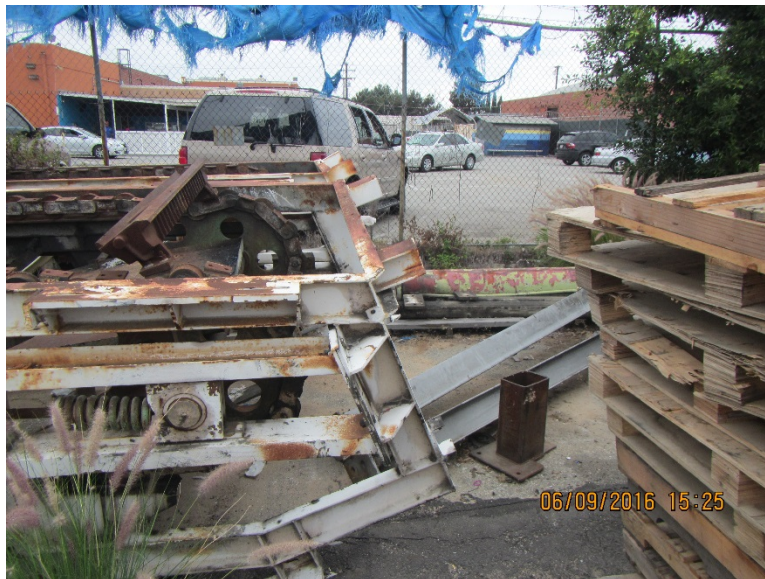
IMG_0188.JPG. Facility boundary behind blue storage bin in Image 0170 (westward view)

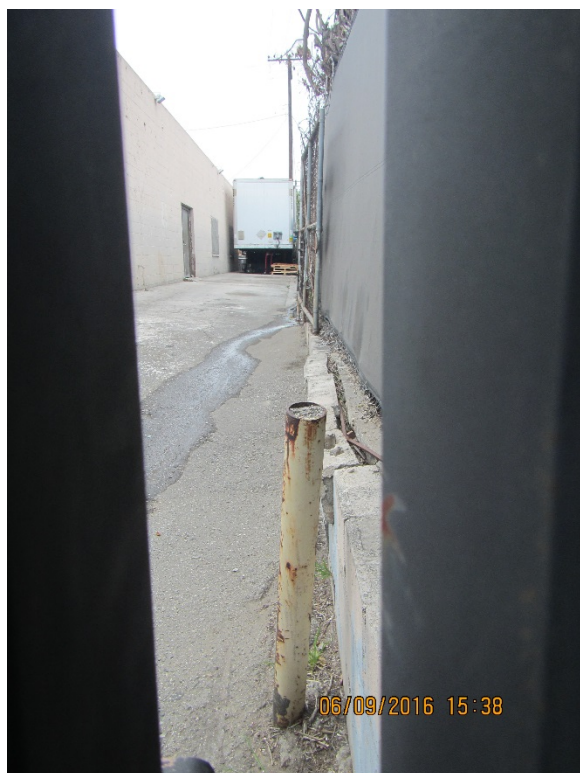
IMG_0195.JPG. Image through gate of discharge from neighborhood facility of Image 0194.

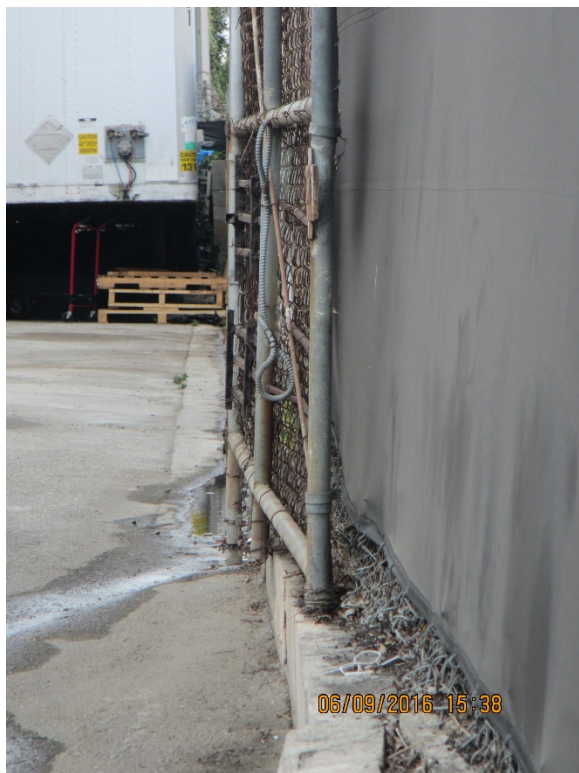
IMG_0196.JPG. Zoomed in image of 0195.

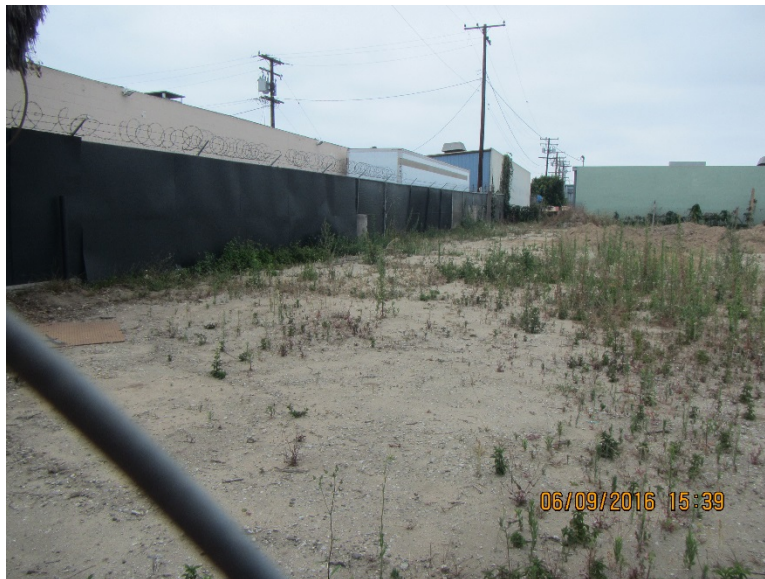
IMG_0197.JPG. Street view through gate of southward alternative flow path B along facility boundary (northward view of Image 0183).

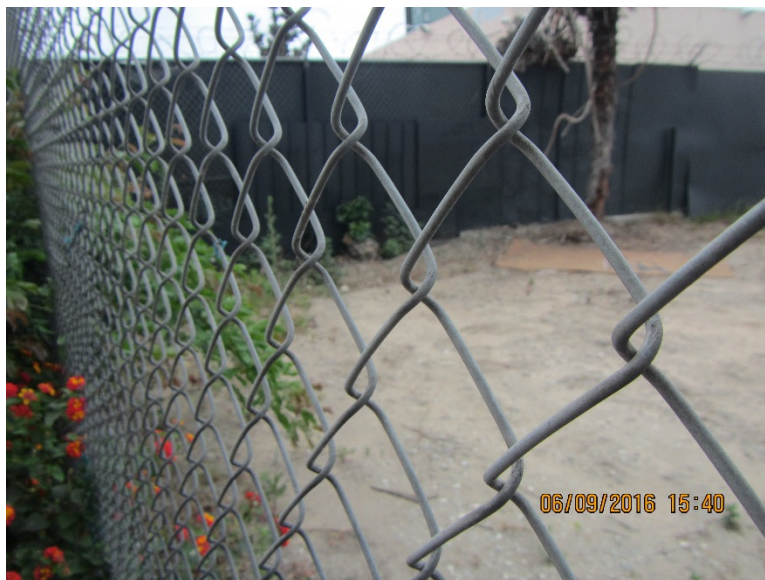
IMG_0198.JPG. Street view through gate of southward alternative flow path B along facility boundary continued from Image 0197.

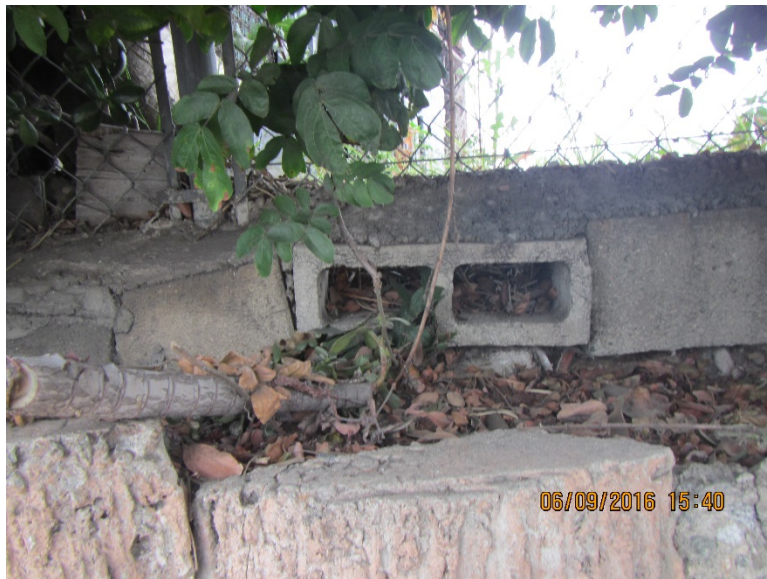
IMG_0199.JPG. Potential discharge location of alternative flow path B (street view from Image 0194).

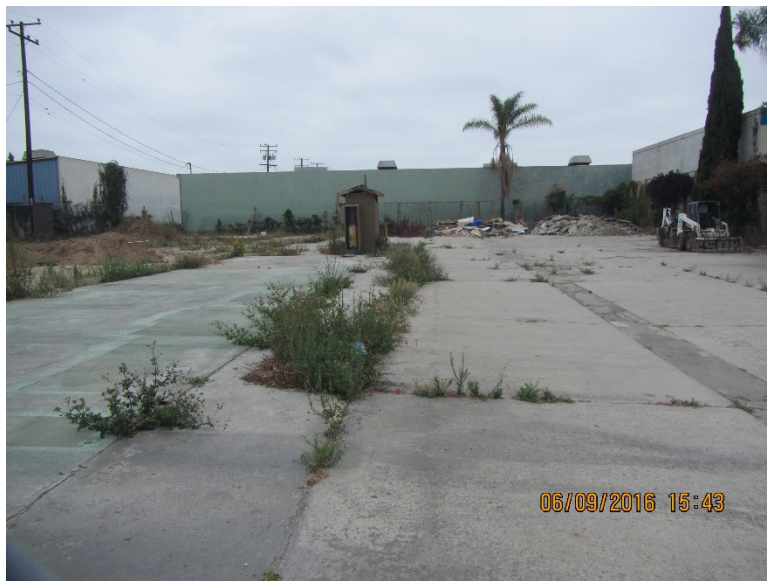
IMG_0201.JPG. Alternative flow bath A commencing from far left corner (Image 0177) along building boundary (Image 0179). Note stormwater trench along vacant parking lot.

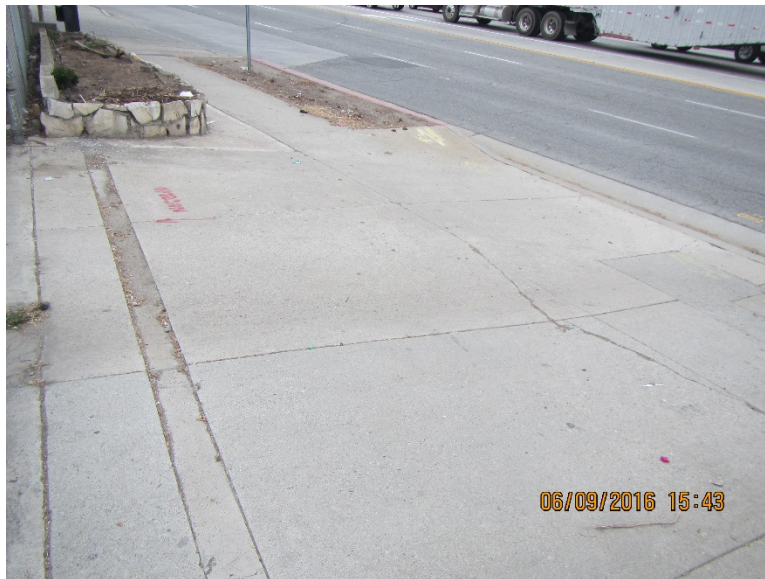
IMG_0202.JPG. Potential discharge point for stormwater trench from Image 0201.

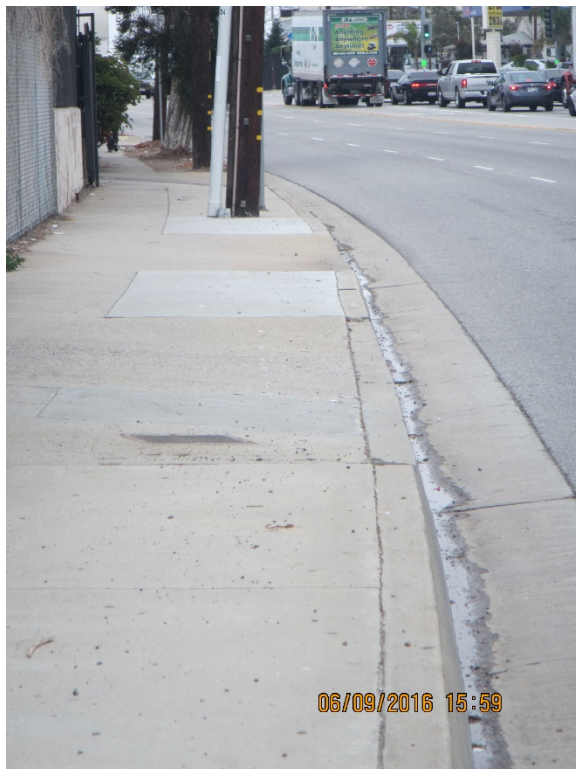
IMG_0204.JPG. Flow from neighboring facility illustrating potential flow path of alternative flow path discharge point A (Image 0202) or alternative flow path discharge point B (Image 0199).

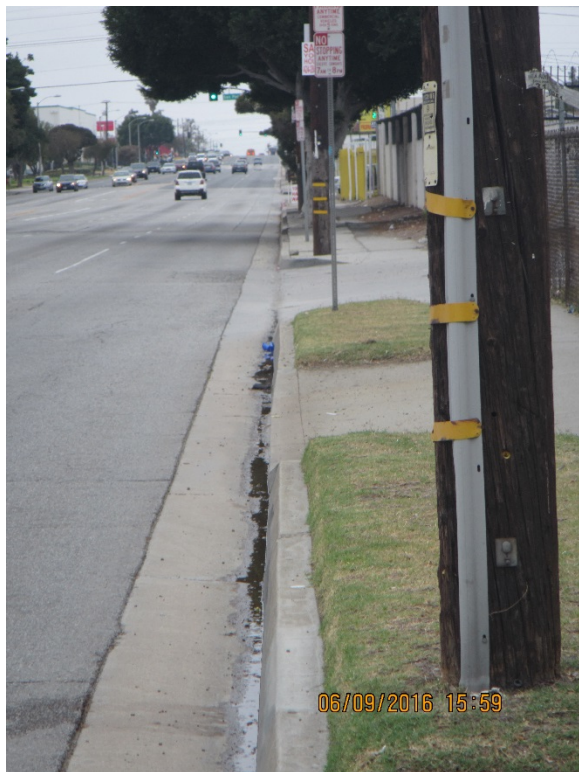
IMG_0205.JPG. Continuation of potential flow path along street curb westward from Image 0204.

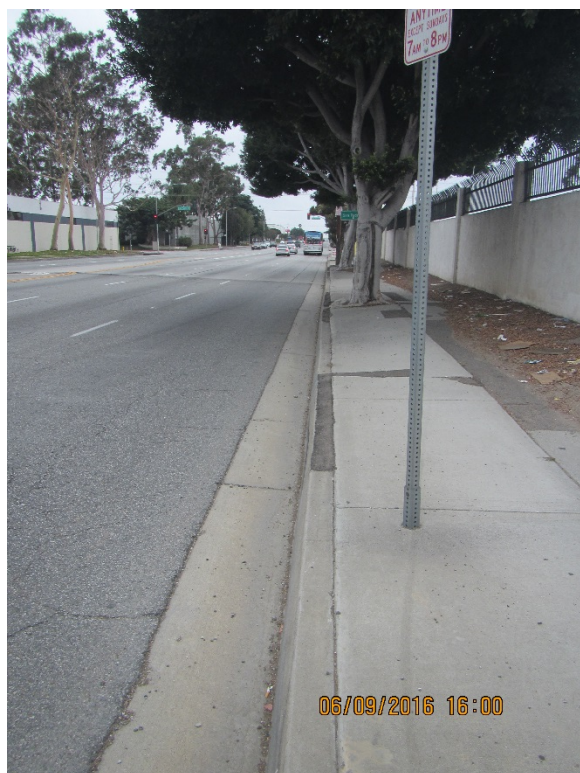
IMG_0207.JPG. Continuation of potential flow path along street curb westward from Image 0205.

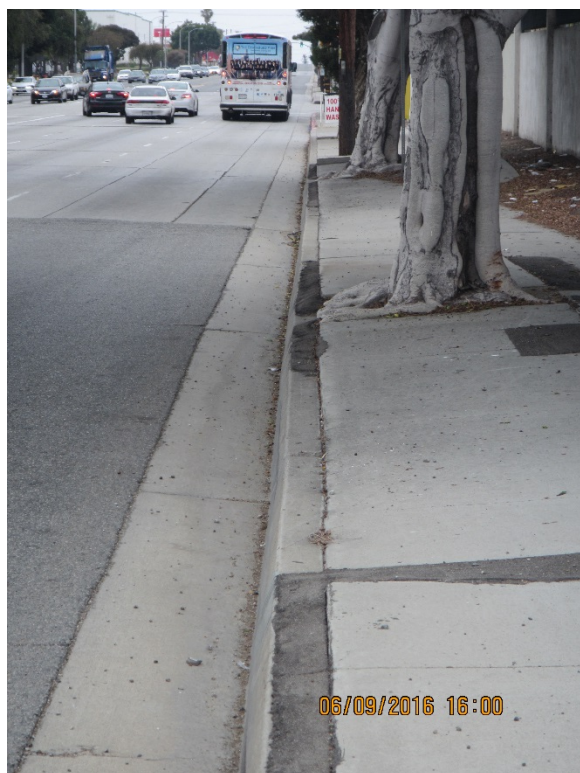
IMG_0208.JPG. Continuation of potential flow path along street curb westward from Image 0207.

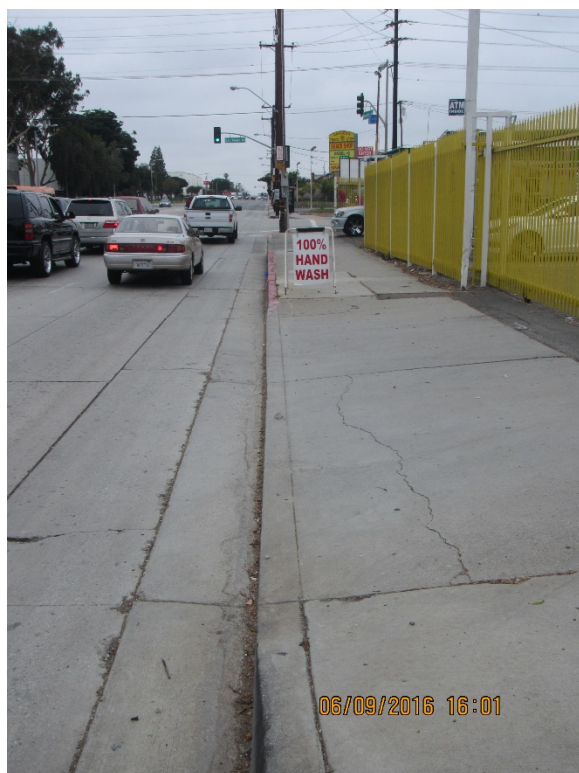
IMG_0209.JPG. Continuation of potential flow path along street curb westward from Image 0208.

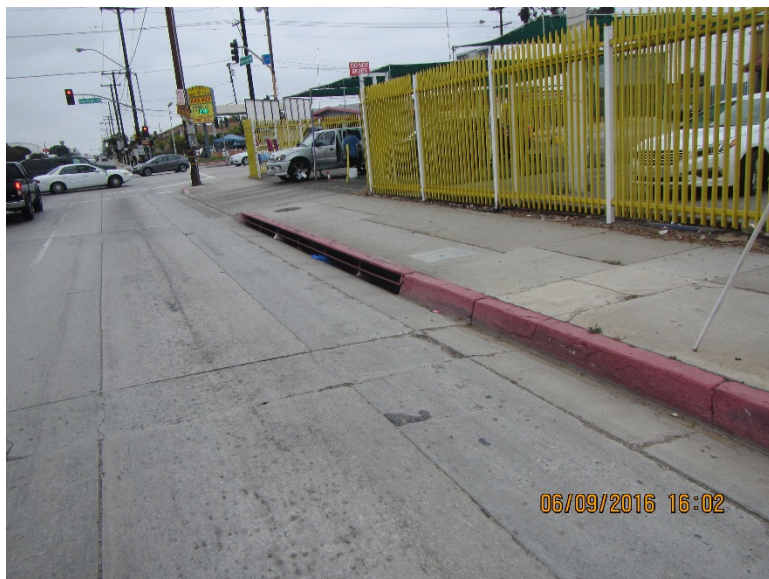
IMG_0211.JPG. Continuation of potential flow path along street curb westward from Image 0209 to Stormwater drain.
